## **Inspection Report**

**Property Address:**  
123 Htown Avenue  
Houston TX 77004

# PROPERTY INSPECTION REPORT FORM

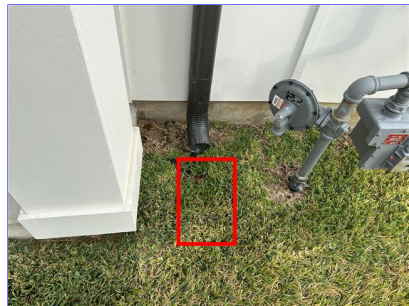
B. Item 1 (Picture)

❌ (3) Gutter downspouts must discharge water at least 36 inches away from the foundation. Discharging roof water next to the home has the potential of causing foundation movement. Concrete Splash Blocks and/or extensions need be installed to achieve proper water run-off.

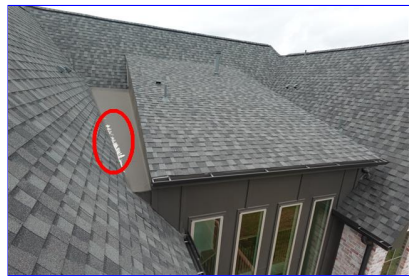
C. Item 19 (Picture)

tightness. Not adequately painting aluminum flashing can lead to moisture infiltration into the building envelope.

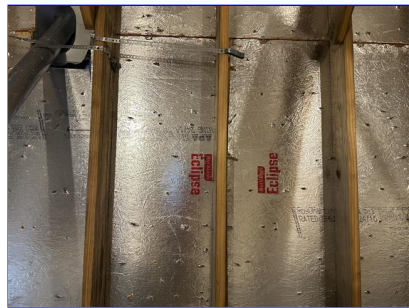
D. Item 1 (Picture)

**Comments:**  
(1) **Note:** Only areas of the Attic determined to be safely accessible by the inspector are inspected. Some areas of the attic were not accessible.  
(2) **Note:** The attic of this home has a Radiant Barrier installed, no concerns with installation. The Radiant Barrier sheathing prevents up to 97% of radiant heat from the sun from entering the attic. Attic temperatures can be reduced by as much as 30 degrees Fahrenheit.

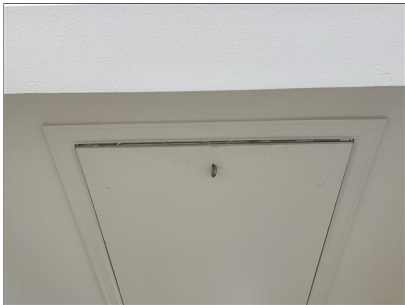
D. Item 13 (Picture)

(4) The Attic Door does not close fully. A qualified Contractor needs to evaluate and make all necessary repairs to allow the door to fully close.

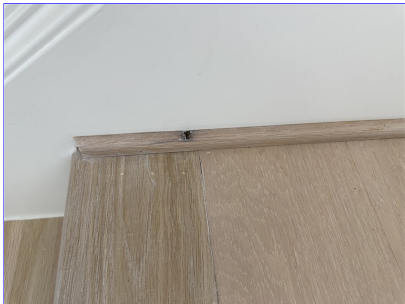
E. Item 1 (Picture)

❌ (2) Damaged quarter round trim was observed at upper run of stairs. A qualified Contractor needs to evaluate and complete all necessary repairs.

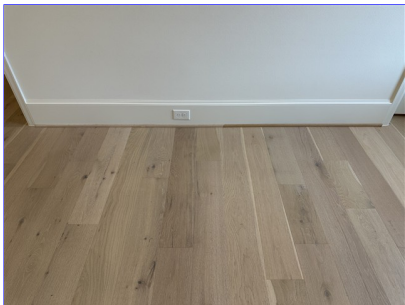
E. Item 2 (Picture)

❌ (3) Front right bedroom quarter round trim does not match. A qualified Contractor needs to evaluate and complete all necessary repairs / replacement.

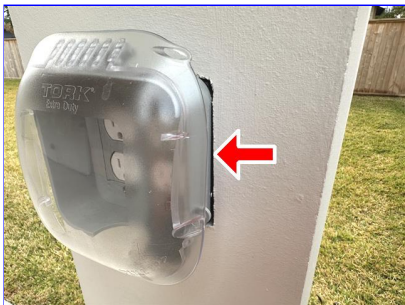
E. Item 3 (Picture)

❌ (4) All holes, gaps, protrusions, and fixtures mounted on the exterior wall must be properly sealed. A quality exterior caulk needs to be used to seal around pipes, wires, light fixtures, holes, etc. This will prevent moisture related failure of electrical components, siding materials, and prevent moisture / insect intrusion into the wall cavity. A qualified Contractor needs to evaluate and complete all necessary corrections.

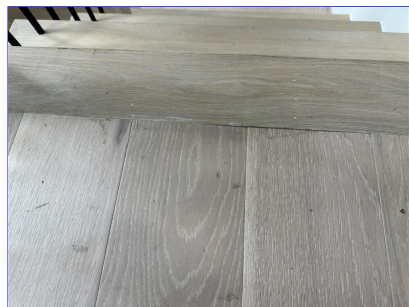
F. Item 2 (Picture)

❌ (2) Excess paint at the top of the stairs needs removal by a qualified Painter.

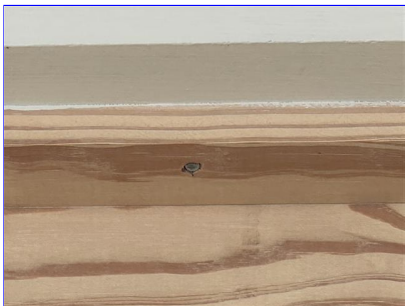
F. Item 5 (Picture)

⬆️ (4) It is advised to consult with a qualified Contractor to seal the wood plank "tongue & groove" exterior ceilings.

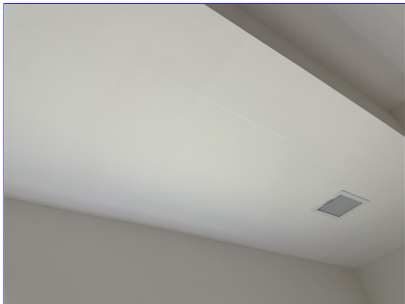
F. Item 8 (Picture)

(5) There is evidence of previous repairs on the ceiling in the primary bedroom. Recommend asking the Seller(s) for the history of the repairs.

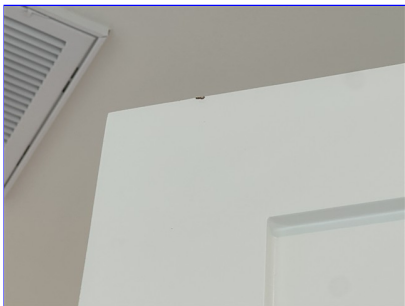
G. Item 1 (Picture)

(2) Observed small chip at top of office door. A qualified Contractor needs to evaluate and complete all necessary repairs.

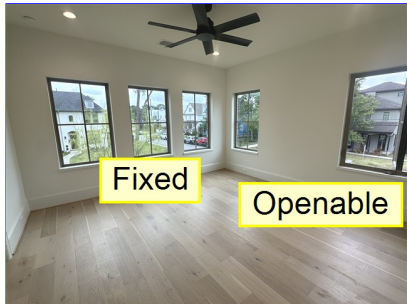
H. Item 1 (Picture)

(3) **Note:** Only one window in each bedroom is openable. Most of the bedroom windows are fixed.

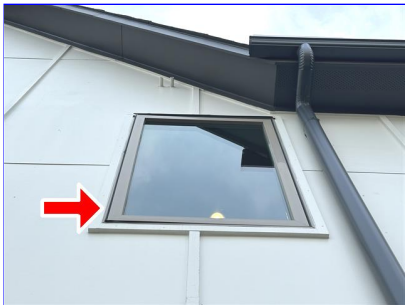
H. Item 5 (Picture)

❌ (5) Window above A/C Condenser does not appear to be installed properly and the frame is protruding from the wall. A qualified Window Technician needs to evaluate and complete all necessary repairs.

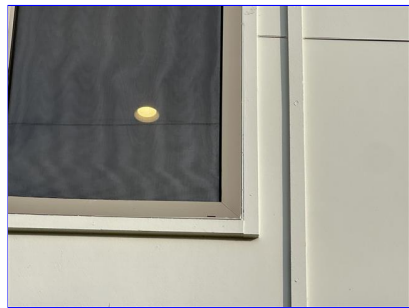
H. Item 9 (Picture)

❌ (6) Some windows at the exterior have deteriorated caulking. All affected windows need to be properly

sealed with Exterior Rated Sealant by a qualified Contractor to prevent moisture intrusion into wall cavity. It is important to check all four sides of window framing to make sure all are properly sealed.

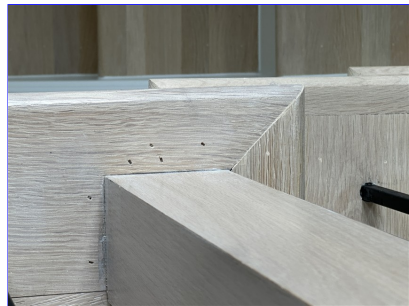
I. Item 1 (Picture)

❌ (2) Nail holes at stairs need to be properly sealed and stained to match stairs. A qualified Contractor needs to evaluate and complete all necessary repairs.

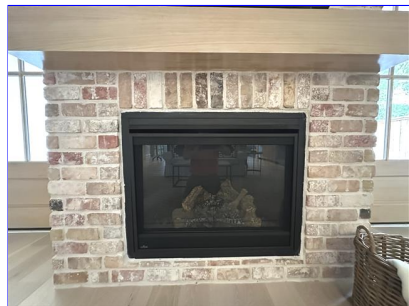
J. Item 1 (Picture)

(2) Fireplace was functional from the wall switch at the time of inspection.

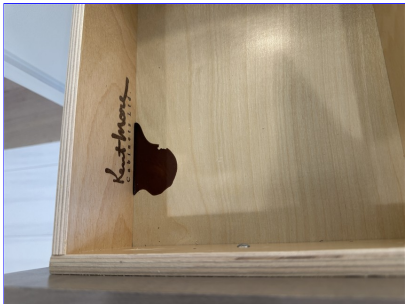
L. Item 2 (Picture)

❌ (4) A qualified Contractor needs to remove the unknown substance that is stuck on the interior of the primary bathroom cabinet drawer.

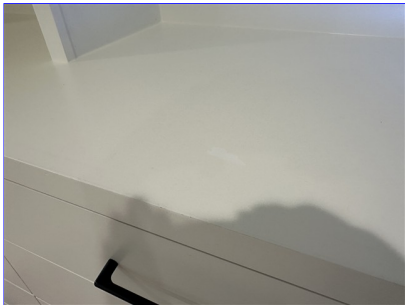
L. Item 3 (Picture)

❌ (5) Observed damaged finish at the cabinetry in the primary bedroom closet. A qualified Contractor needs to evaluate and complete all necessary repairs.

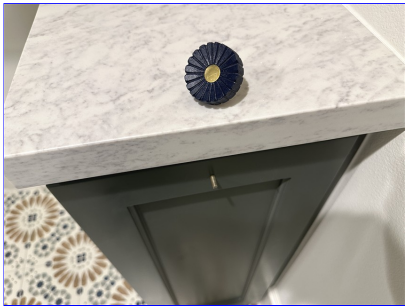
L. Item 4 (Picture)

❌ (6) Detached cabinetry knob was observed in the utility room. A qualified Contractor needs to properly attach it.

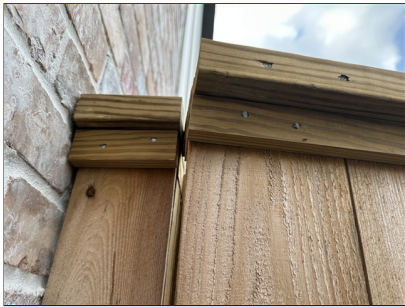
L. Item 5 (Picture)

❌ (7) Right side gate improperly strikes the gate. A qualified Contractor needs to evaluate and complete all necessary repairs so the gate is fully functional.

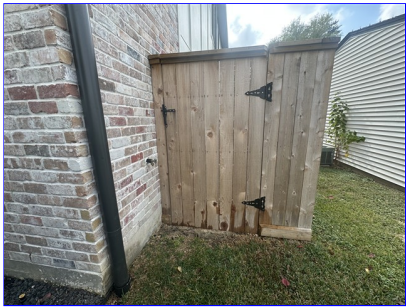
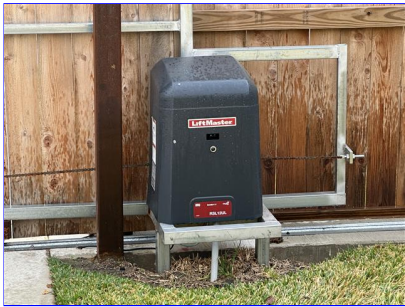
L. Item 6 (Picture)

❌ (8) It is advised to have the Seller(s) demonstrate proper operation of the automatic gate and provide remotes / access codes.

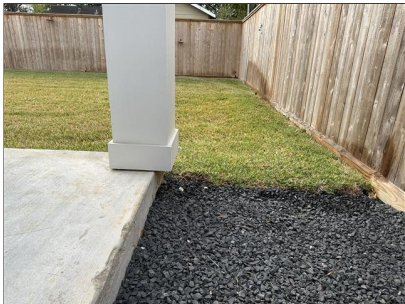
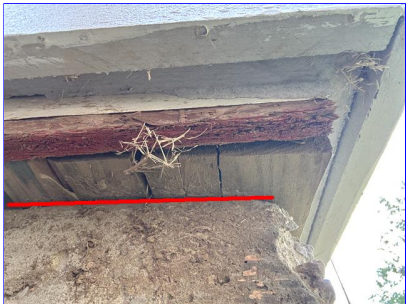
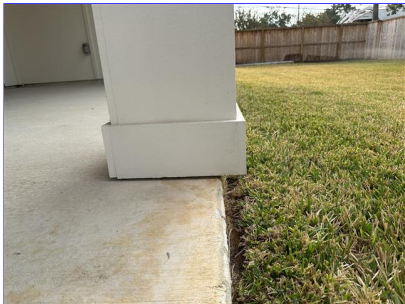
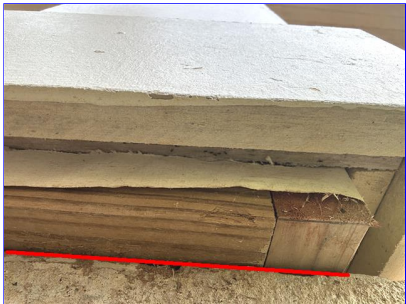
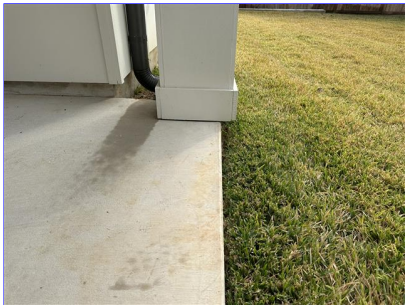
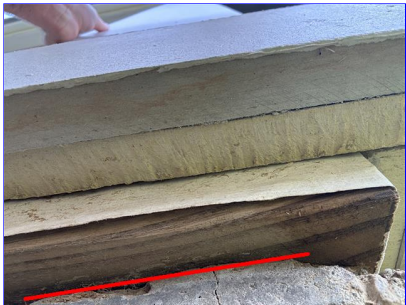
L. Item 14 (Picture)

(10) Rear porch columns do not have the required full end bearing and support on the concrete slab. A qualified Contractor needs to evaluate and complete all necessary repairs so proper support is present at the rear porch columns. Damaged and cracked concrete underneath the columns need repair and it is likely that concrete will continue to exhibit failure due to the excess weight of the column overhang putting pressure on the concrete.

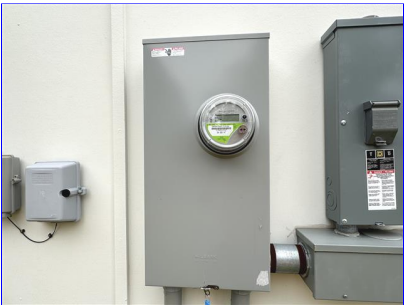
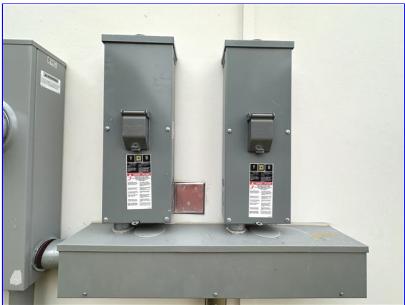
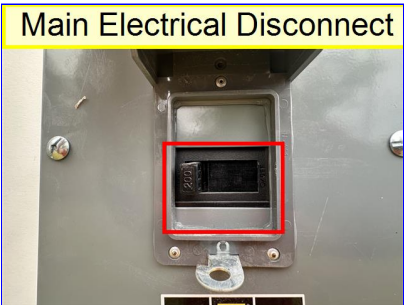
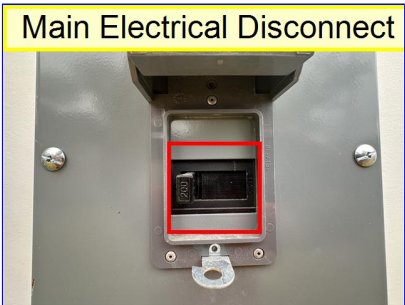
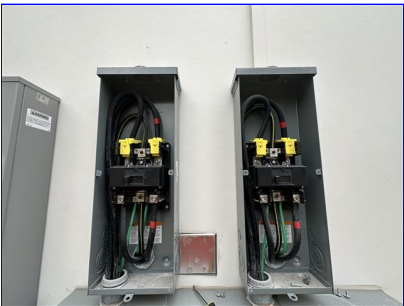
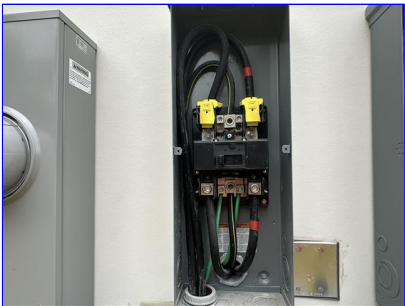
A. Item 1 (Picture)

**Note:** It is beyond the scope of this inspection to determine present or future sufficiency of service capacity amperage, voltage, or the capacity of the electrical system. ARC fault circuit interrupter devices are not tested when the property is occupied, since damage to personal property may result. It not within the scope of this inspection to conduct voltage drop calculations, determine the accuracy of over-current device labeling, remove covers where judged hazardous by the inspector, or operate over-current devices.  
(2) Main Electrical Panels & Electric Meter are located at the rear of the home and the Sub Panels are located in the garage. The Legends were properly labeled. The thermal image scan of the panels did not reveal any abnormal heat signatures.

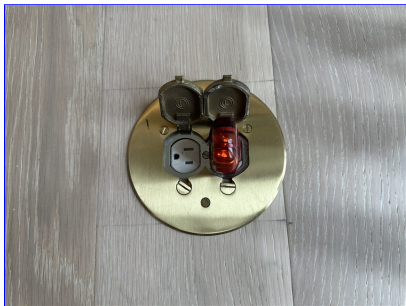
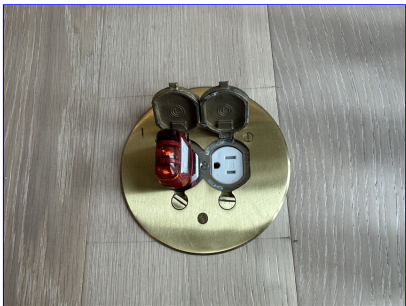
B. Item 1 (Picture)

- (4) **Note:** Carbon Monoxide Detectors must be installed in all proper locations for any home with gas fired appliances or an attached garage.
- (5) **Note:** Floor receptacle outlets were functional at the time of inspection.

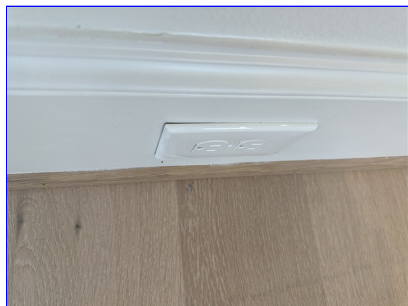
B. Item 6 (Picture)

⊗ (8) Receptacles are improperly protruding from outlet boxes. A qualified Licensed Electrician needs to adjust all affected receptacles so they are completely flush at the wall to prevent access to live electrical components.

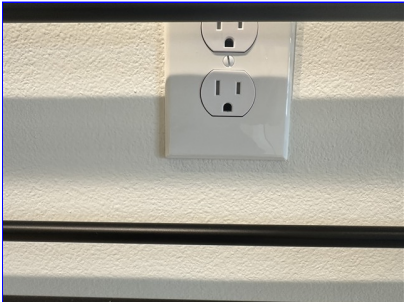
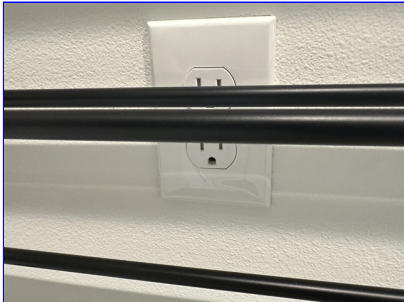
B. Item 8 (Picture)

❌ (10) Receptacle outlets in room near entry with glass doors are partially obstructed and the top outlet cannot be accessed for use and was not tested for proper operation. A qualified Contractor needs to evaluate and complete all necessary repairs.

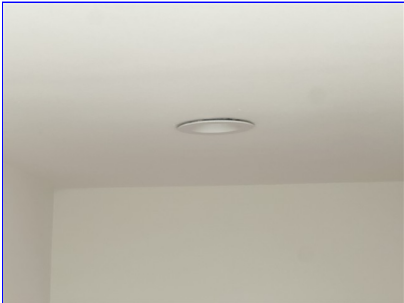
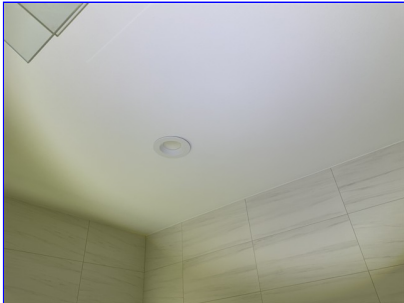
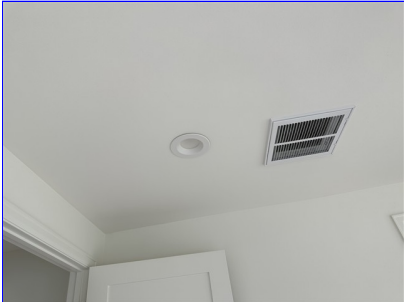
B. Item 10 (Picture)

❌ (11) Some lights appear they may be loose and not properly attached at the ceiling. A qualified Licensed Electrician needs to evaluate and complete all necessary repairs.

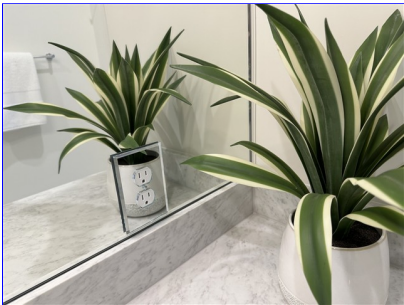
B. Item 14 (Picture)

❌ (12) Right side middle secondary bathroom receptacle is very loose at the wall. A qualified licensed Electrician must evaluate and complete all necessary repairs and corrections to electrical receptacles in the home by properly securing all receptacles. Some Receptacles were loose and / or recessed into the wall when tested with a Plug Tester. Loose Receptacles will allow wires to loosen over time and fail. A loose electrical outlet may seem like a minor inconvenience but in fact, it is a serious safety concern. The loosening of the outlet can expose you to sparks, high voltage, and other electrical hazards, all of which pose a risk of electric shock or, even worse, a fire. Although this is a safety concern, a qualified licensed Electrician can complete simple repairs to fix the problem by adding shims, installing box extenders, replacing the receptacles, or by adding a metal wall plate spacer. These repairs must be completed to ensure the safety of all occupants.

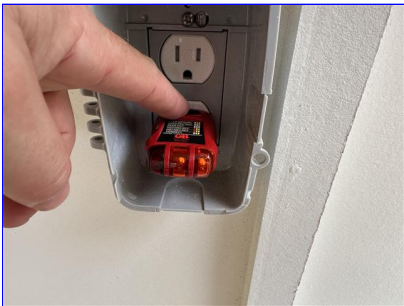
B. Item 15 (Picture)

❌ (13) There is no GFCI (Ground Fault Circuit Interrupter) protection at the rear porch 120V receptacle outlet. This outlet need to be replaced and / or wired to a correct, existing GFCI Circuit by a qualified licensed Electrician with receptacles that provide the required GFCI Protection.

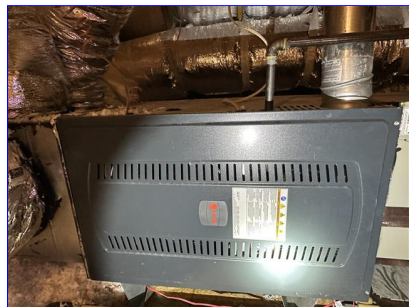
A. Item 1 (Picture)

(2) Heating Units were functional at the time of inspection. Proper heating operation is determined by a minimum of 100 degrees measured from the supply vents.

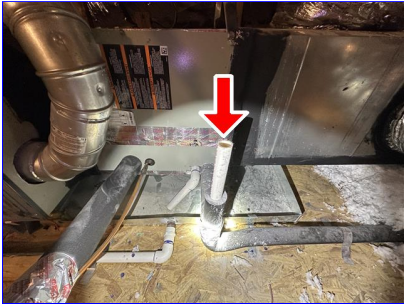
B. Item 1 (Picture)

(4) **Note:** Secondary Drain Line Termination Points for the A/C units are located on the right side of the home. If these drains are seen leaking then it means the Primary Drain Lines are clogged and the units needs service by a licensed HVAC Technician.

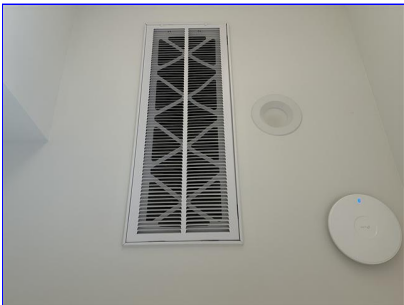
B. Item 3 (Picture)

(5) **Note:** Cartridge Filters for the A/C unit are located in the Return Vents. It is advised that Filters be changed frequently or per the manufacturers instructions. Dirty Air Filters cause premature wear on A/C systems and decrease indoor air quality.

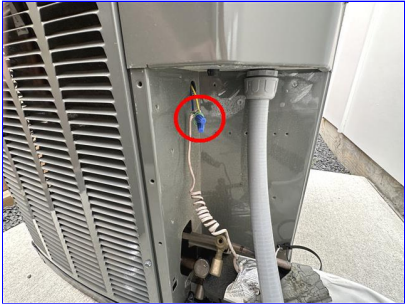
B. Item 25 (Picture)

❌ (8) Observed improper splicing at thermostat wiring outside of the condenser cabinets. A qualified Licensed HVAC Technician needs to properly conceal the spliced wires inside the condensers cabinets to prevent mechanical damage. If these wires are damaged it could cause system shutdown.

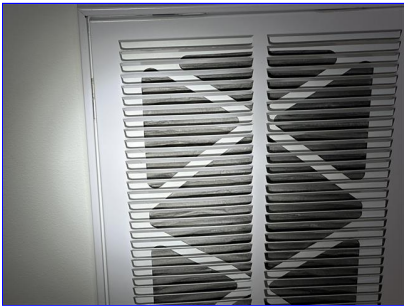
B. Item 27 (Picture)

(9) A/C Air Filters are dirty and need replacement. Proper maintenance of the air filters is important for the efficiency of the HVAC unit. A dirty or clogged air filter restricts the air flow through the system and can cause premature damage to the system. Air Filters need to be checked monthly and changed every 3-6 months or per manufacturers instructions.

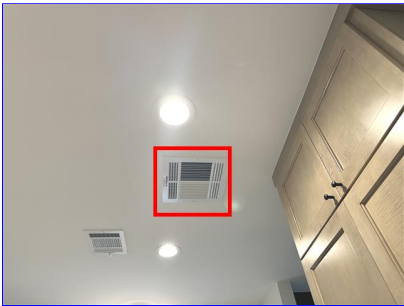
B. Item 28 (Picture)

(10) Air flow is not being delivered from the A/C supply vent in kitchen. It could be that the builder installed this vent as a mistake and now it is abandoned. A qualified Licensed HVAC Technician needs to evaluate and complete all necessary repairs and corrections.

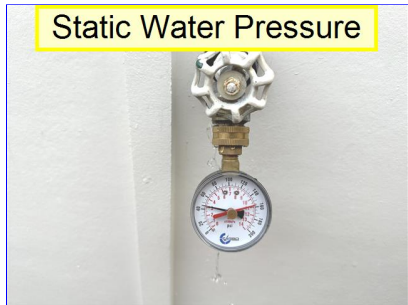
A. Item 1 (Picture)

(3) Fixtures functional. Flow/Volume acceptable. The toilets flushed properly. Static Water Pressure measured from the hose bibb was 45 PSI. The acceptable range per industry standards is 40 – 80 PSI.

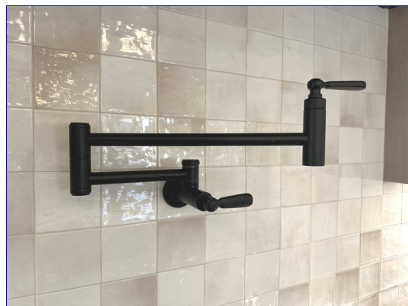
A. Item 2 (Picture)

(4) **Note:** Pot filler was functional at the time of inspection.

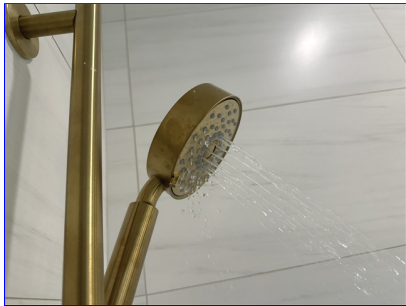
A. Item 10 (Picture)

(10) Handheld sprayer in the primary bathroom shower is partially clogged. A qualified Contractor needs to properly clean the sprayer ports. If that does not resolve the issue then a qualified Licensed Plumber needs to evaluate and complete all necessary repairs.

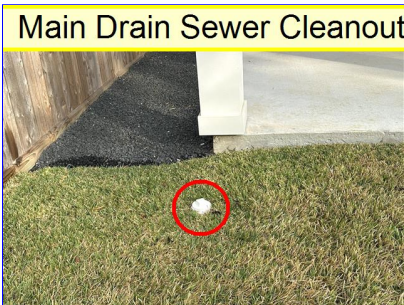
B. Item 7 (Picture)

(3) Main Drain Sewer Clean-Out is located at the rear of the home. Do not bury this important component.

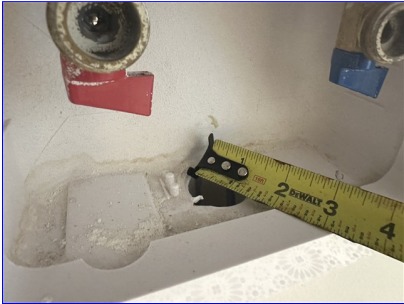
B. Item 8 (Picture)

⊗ (4) Observed washer drain size is 1.5 inches in diameter. The washer drain line size needs to be at least 2 inches in diameter to accommodate drainage needs for modern washers. A qualified licensed Plumber needs to evaluate and complete all necessary repairs.

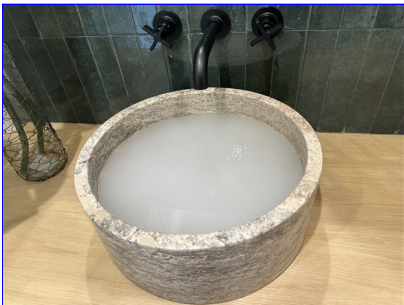
C. Item 4 (Picture)

❌ (3) Discolored and cloudy water was delivered from the hot water side of all plumbing fixtures. This is indicative that the water heater may need to be flushed or some other issue resolved. A qualified Licensed Plumber needs to evaluate and complete all necessary repairs.

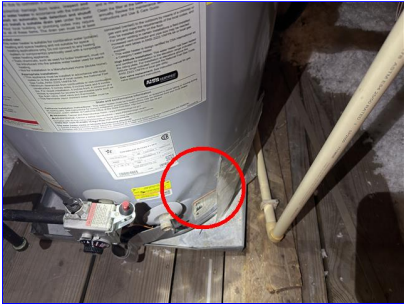
C. Item 5 (Picture)

❌ (4) Observed a significant dent in the water heater tank. Further evaluation is needed by a qualified licensed Plumber to ensure the damage does not affect the performance of the water heater and tank needs replacement as needed.

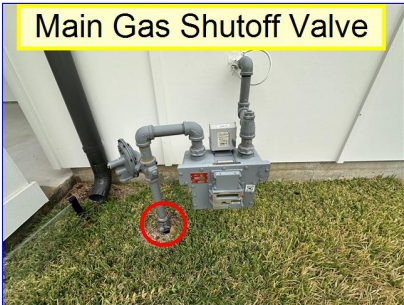
E. Item 1 (Picture)

Gas Meter and Main Gas Shutoff Valve are located at the rear of the home. Visible Bonding was identified at the gas pipe.

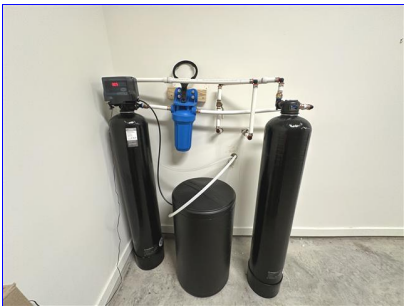
F. Item 1 (Picture)

ⓘ Water Softener Systems are not part of a standard Home Inspection. Recommend having a company that specializes in Water Softeners fully evaluate the system for proper operation and educate the homeowner on system functions and maintenance.

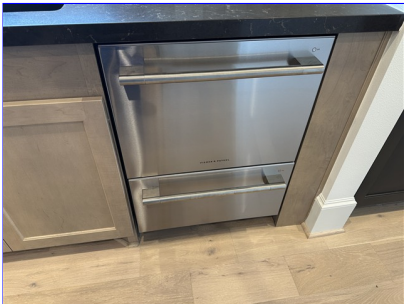
A. Item 1 (Picture)

(1) Dishwasher was functional when tested on a normal cycle and fully drained. The spray bars activated as well as the detergent dispenser. The Inspector is not required to operate and determine the condition of other auxiliary components of inspected items.

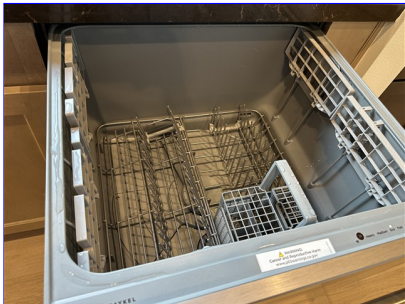
A. Item 2 (Picture)

☒ ☐ ☐ ☐ (2) Temporary clamp at dishwasher drain line needs to be replaced with permanent securement by a qualified Licensed Plumber.

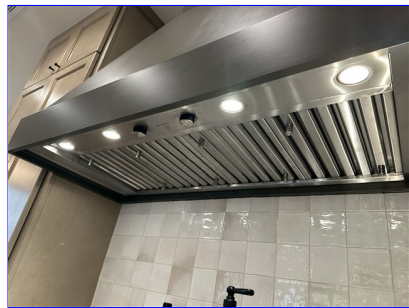
B. Item 1 (Picture)

adequacy of venting systems or determine proper routing and lengths of duct systems.  
(2) Range Hood was functional and vented to the exterior with no concerns noted.

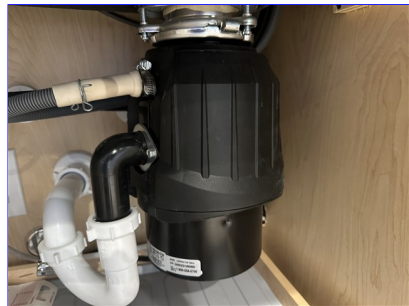
C. Item 1 (Picture)

Food Waste Disposer made a loud, rattling, grinding noise when operated. This is commonly caused by an object obstructing the grinding blades. Repair is needed by a qualified Appliance Technician.

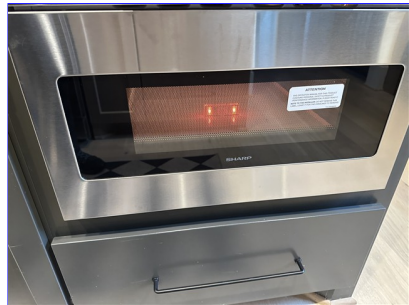
E. Item 1 (Picture)

(2) Microwave functioned properly at the time of inspection.

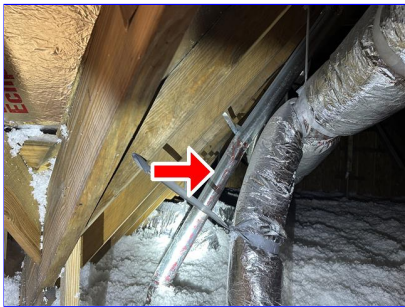
H. Item 1 (Picture)

- (1) **Note:** Dryer vents need to be cleaned every six months to prevent lint build-up, improve efficiency, and reduce possible fire hazards. The dryer vent system is visually inspected where accessible.
- (2) No Deficiencies were observed regarding the Dryer Vent.

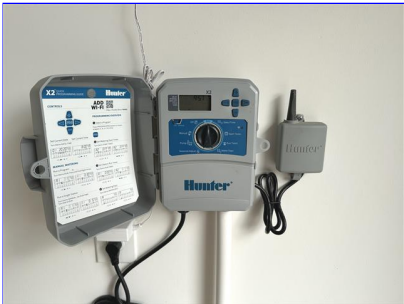
A. Item 1 (Picture)

(2) Tested and operated all 7 zones of the sprinkler system. System operated from the controller in the garage. The pressure vacuum breaker (backflow device) is located at the rear of the home and the rain sensor was located on the left side fence. The isolation valve was located in the yard, just upstream of the pressure vacuum breaker.

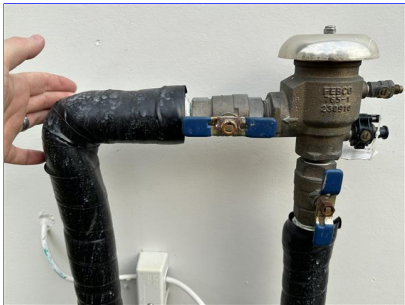
A. Item 12 (Picture)

❌ (4) Piping Dedicated for the Pressure Vacuum Breaker needs securement to the exterior wall by a qualified Contractor to prevent mechanical damage.

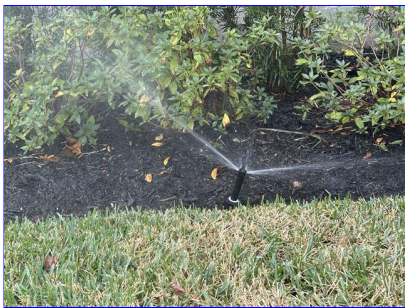
A. Item 13 (Picture)

(5) Zone 1 - Observed a sprayer head that is not vertically plumb. A qualified licensed Irrigator needs to properly straighten all tilted Sprayer Heads so water coverage is achieved at all areas.

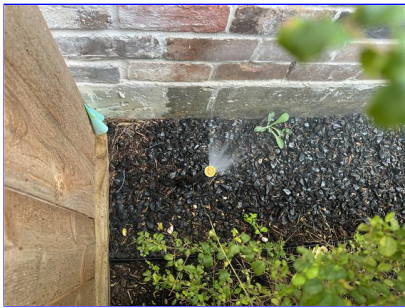
A. Item 14 (Picture)

(6) Zone 2 - Riser head needs adjustment so it does not spray directly onto the home.
